THE TRANSITION FROM BRITTLE TO DUTCHE FAILURE

IN POLYETHELENE

A thesis presented to the Faculty of Enigineering and Applied Science of the University of Pennsylvania in partial fulfillment of the requirements for the degree of Master of Science for graduate work in Mechanical Engineering and Applied Mechanics.

Abstract

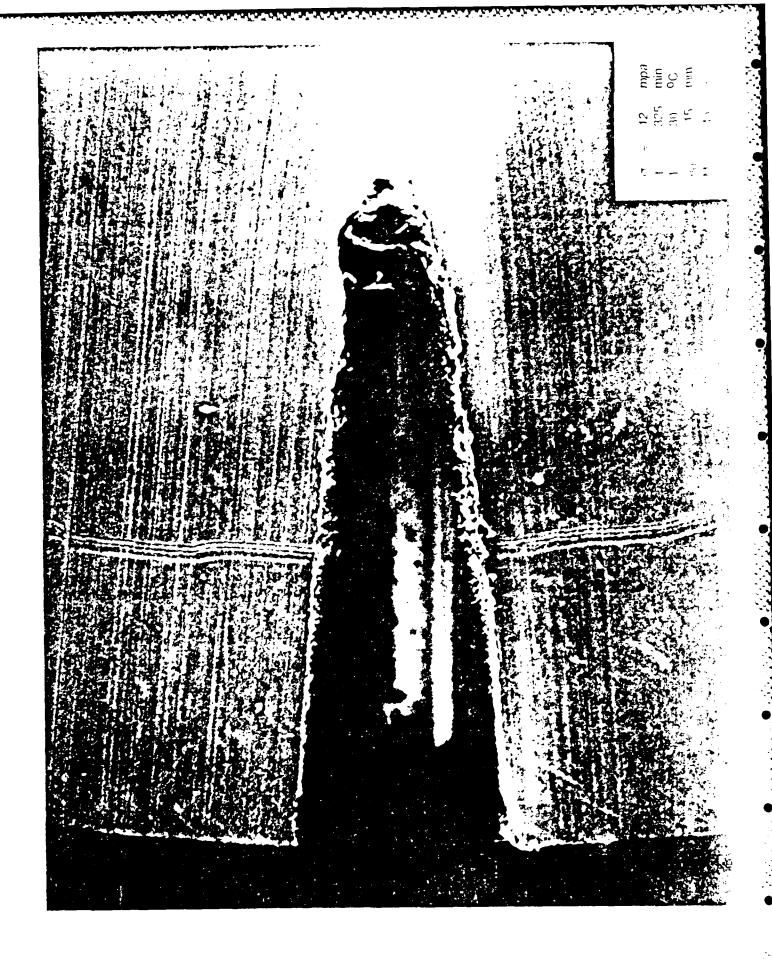
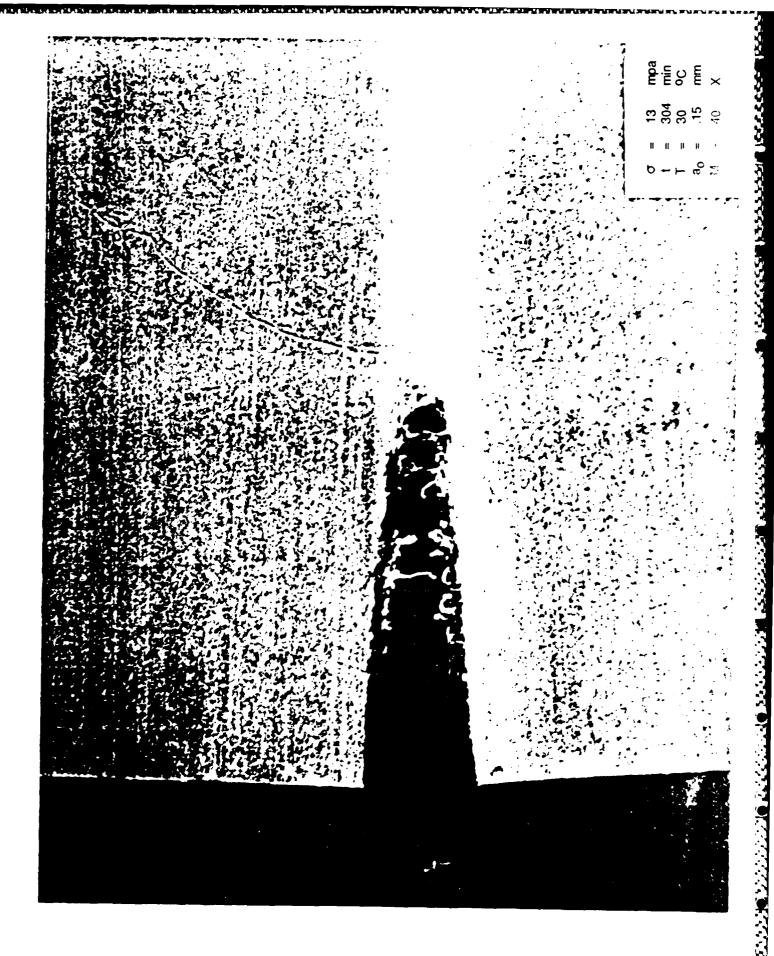
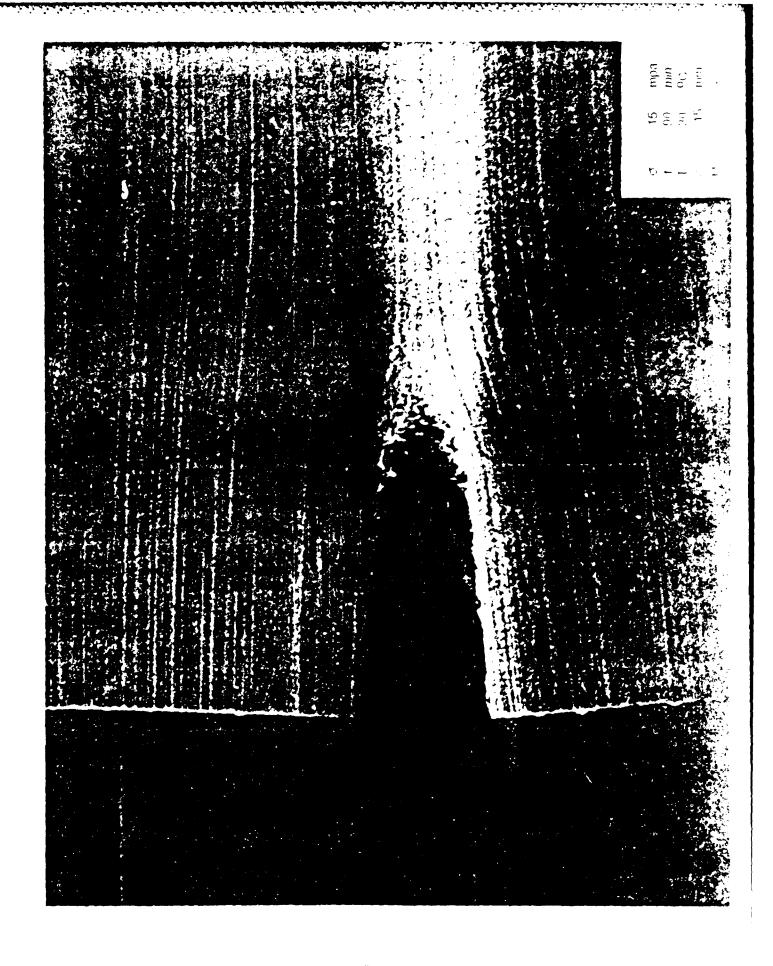
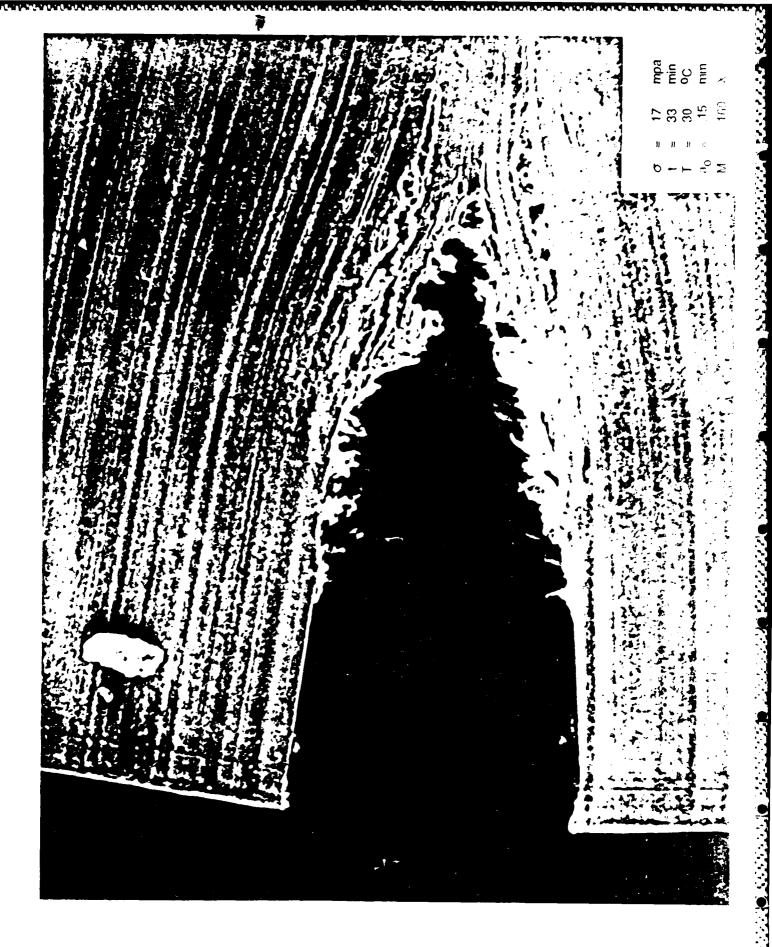
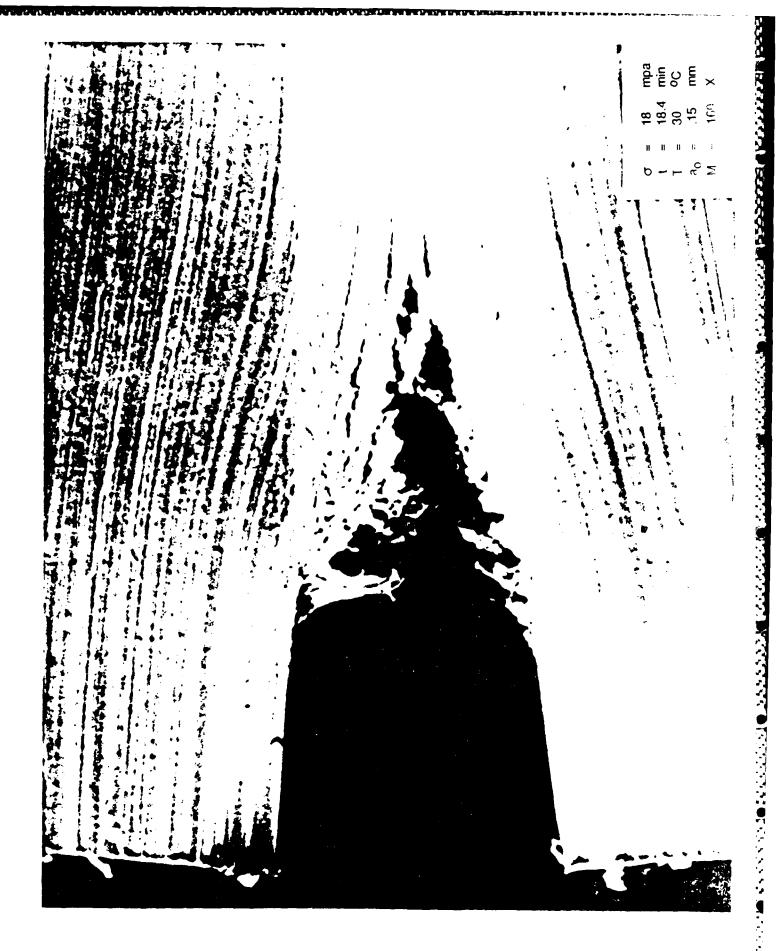
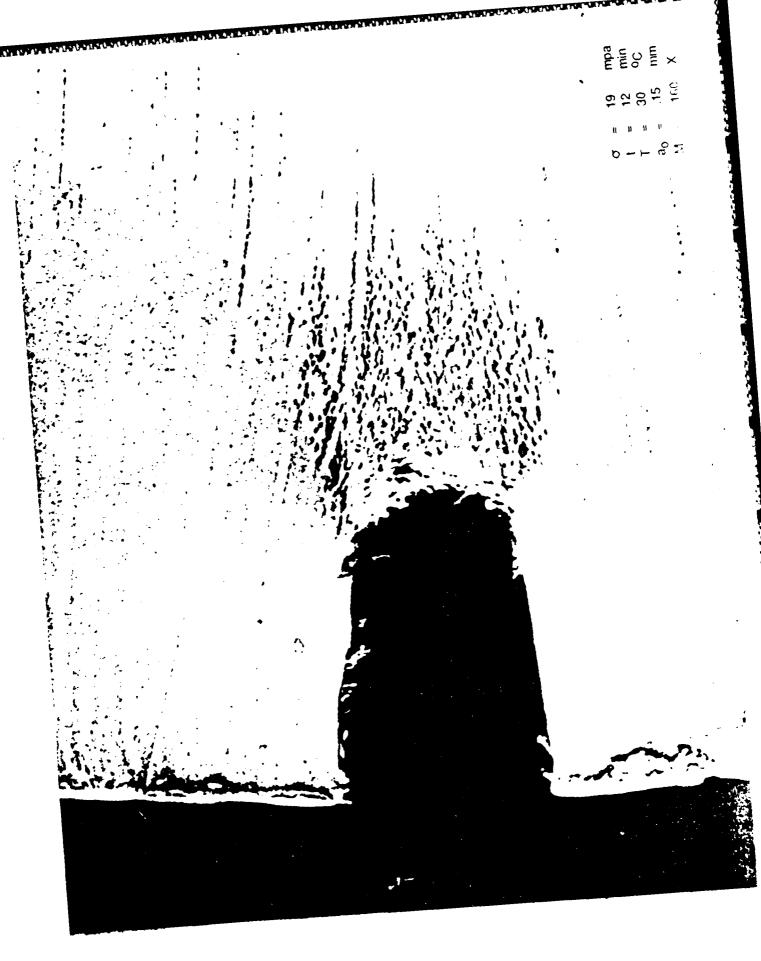
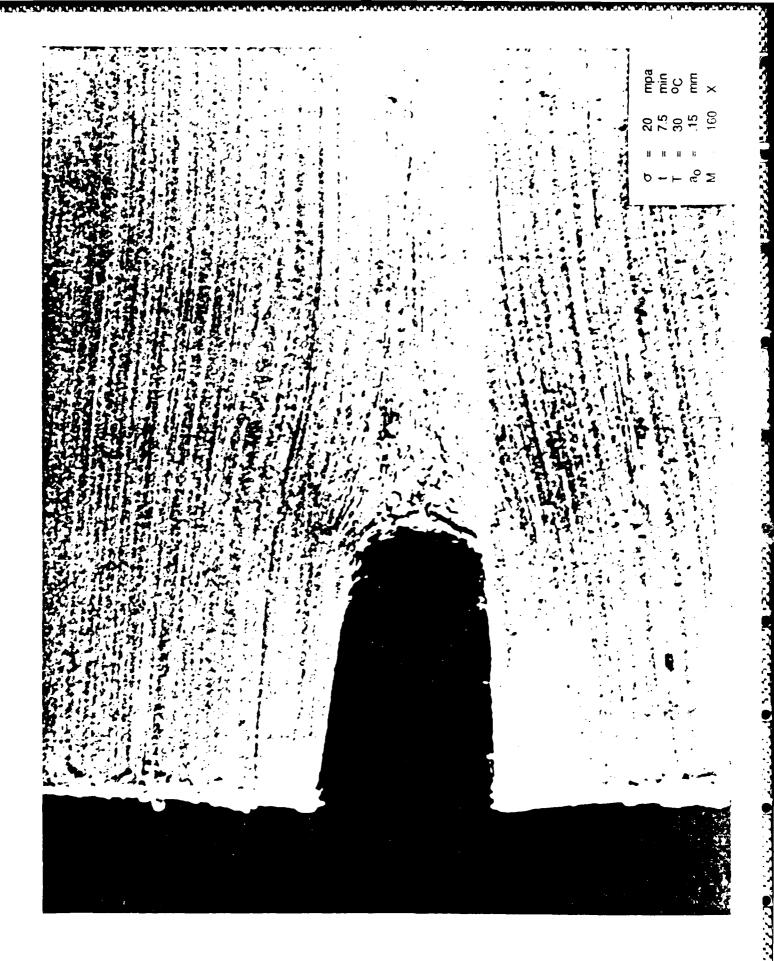
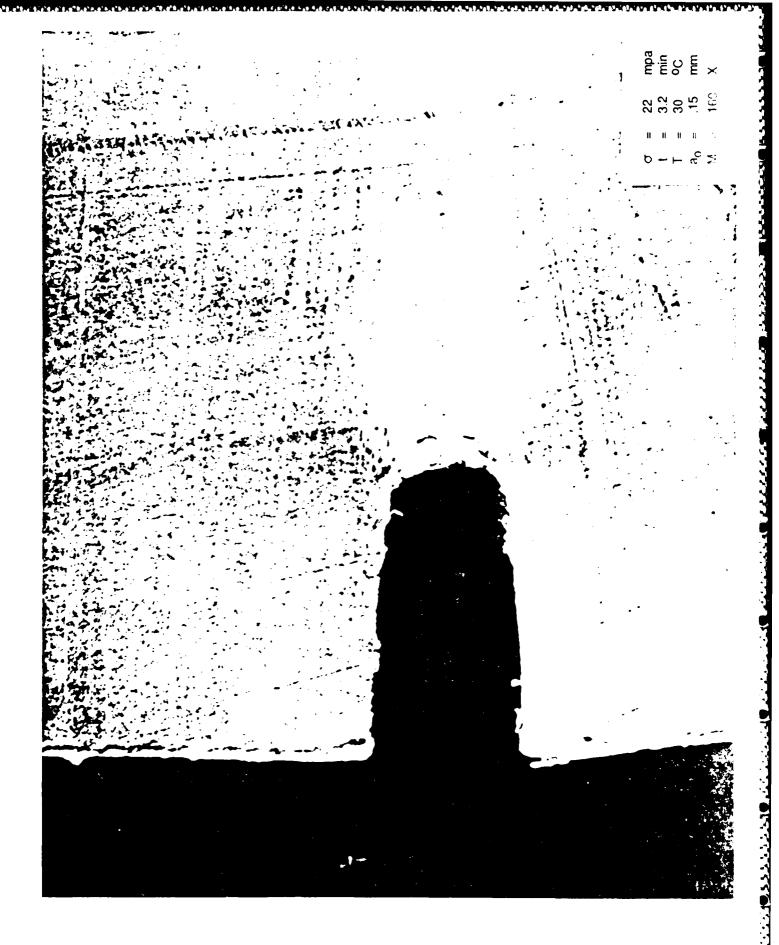
Figures 18 through 26 present electron microscopic studies for Marlex 6006 with a .15mm notch at 30° C for various stress levels (Please note: in order to obtain similar views of the damage zone magnifications are not all identical). At stresses of 12, 13, and 14 mpa the start of brittle failure is evident, that is, the start of fibril fracture, the growth of new fibrils, and the advancing of the damage

zone. The photographs at stresses of 15, 17, and 18 mpa indicate that the brittle fracture initiation process has begun as evident by the presence of fibrils but the process was halted with a general blunting of the crack tip resulting in slowed COD growth which is now limited to growth induced by creep. At stresses of 19, 20, and 22 mpa there is an immediate blunting of the notch tip with no evidence of fibril growth.

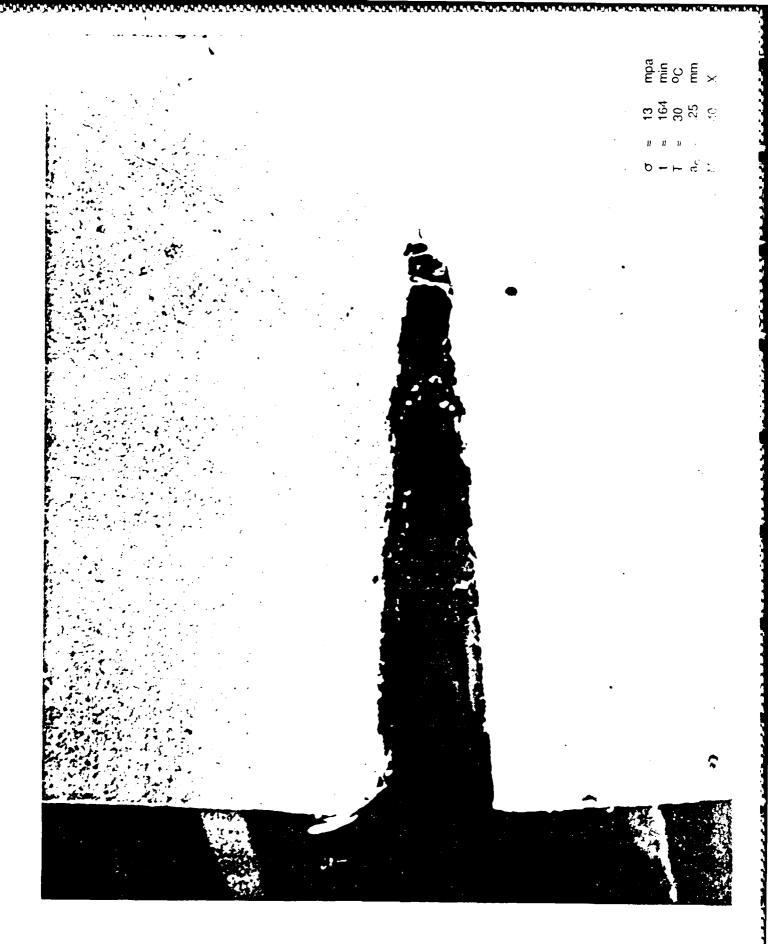
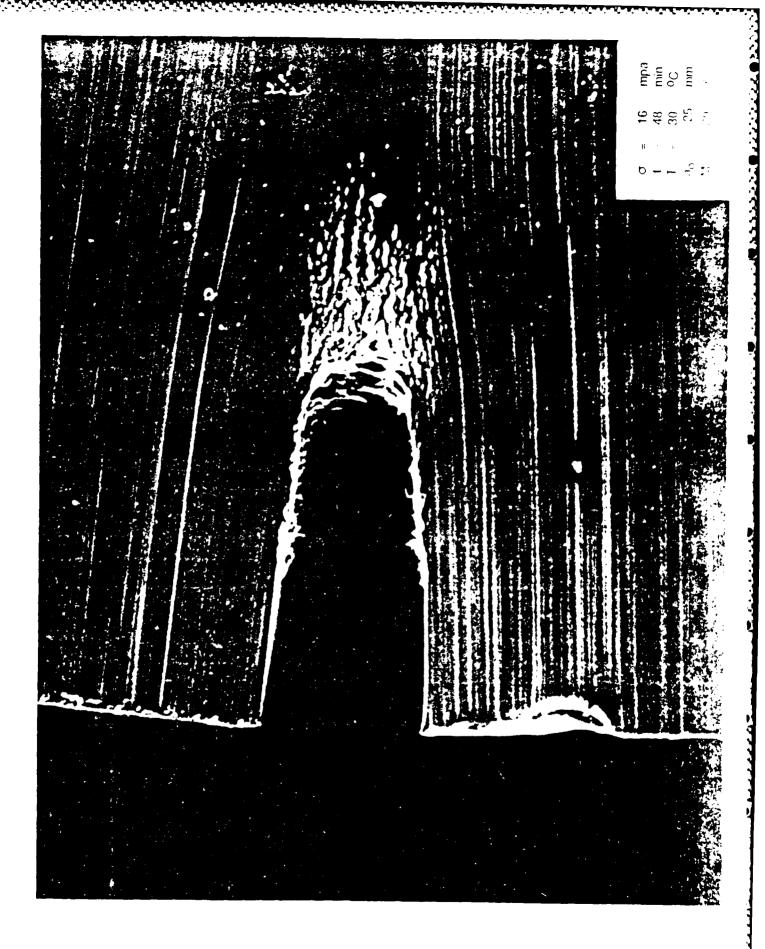
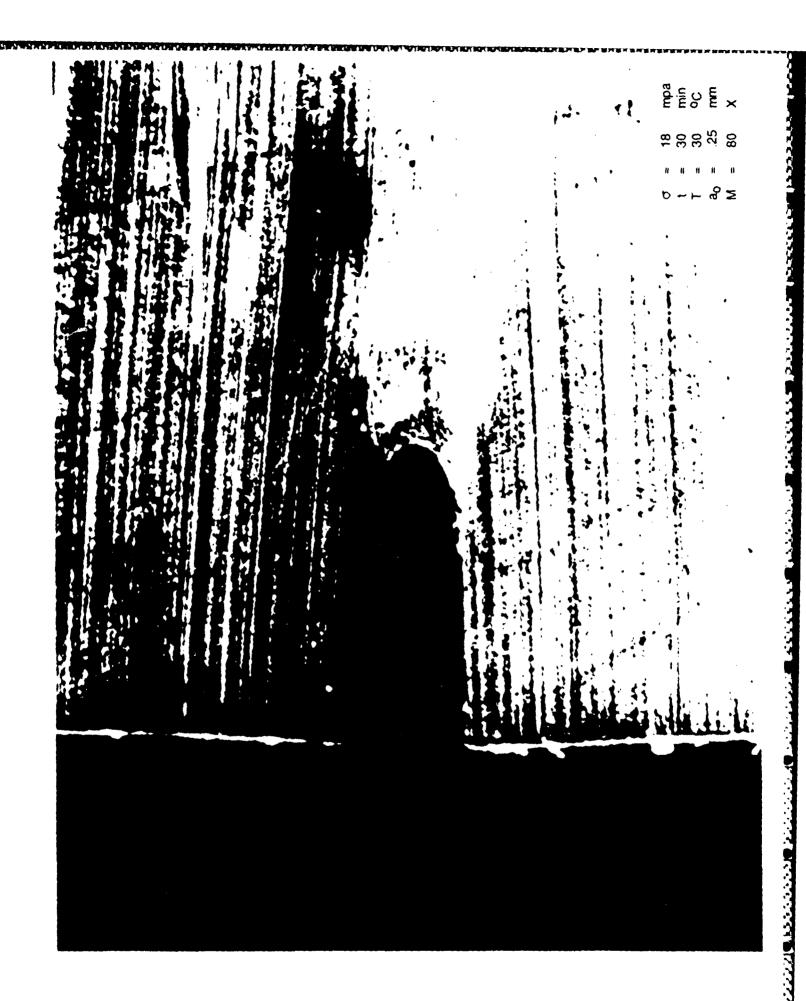
Figures 27 through 30 present electron microscopic studies for Marlex 6006 with a .25 mm notch at 30° C for various stress levels. For 12 and 13 mpa the beginning of brittle fracture is again evident. At 16 mpa there is evidence of fibril formation with blunting of the crack tip and at 18 mpa there is an initial blunting of the notch tip. The photographs for both the .15 and .25 mm notch depths indicate by the shape of the porous damaged area that the shape of the stress field changes from sharp to ballooned. The apparent gradual change in the shape of the stress field is supportative of the transition from brittle to ductile failure.

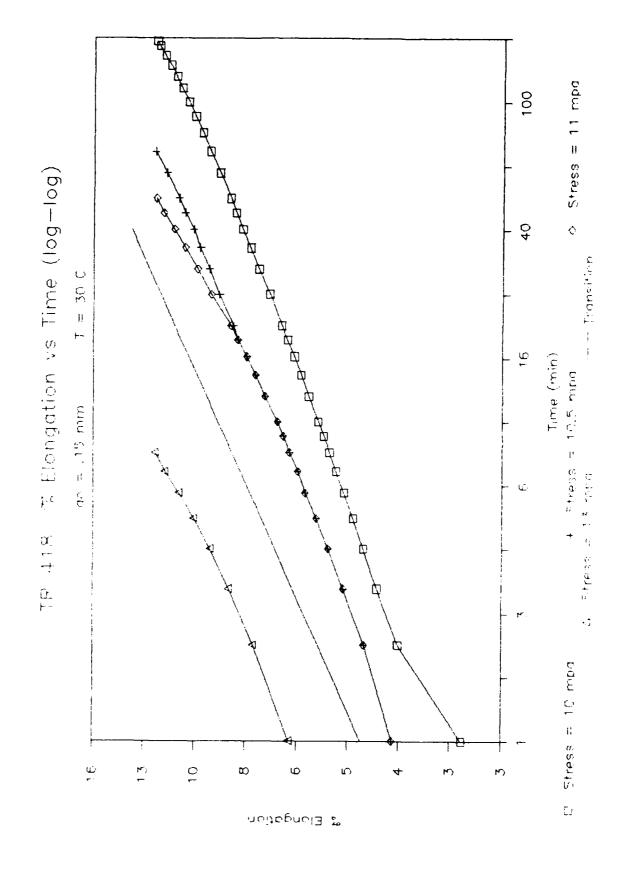
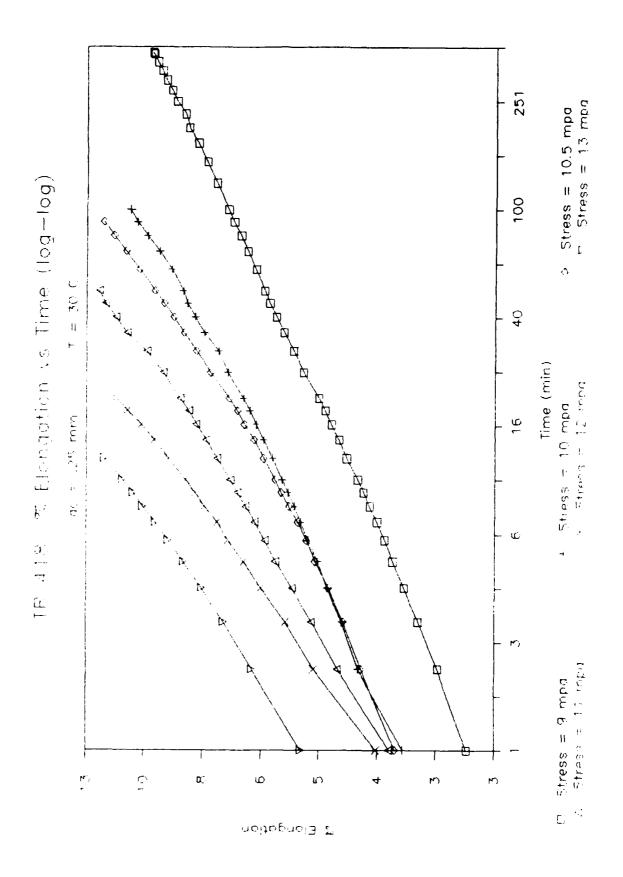
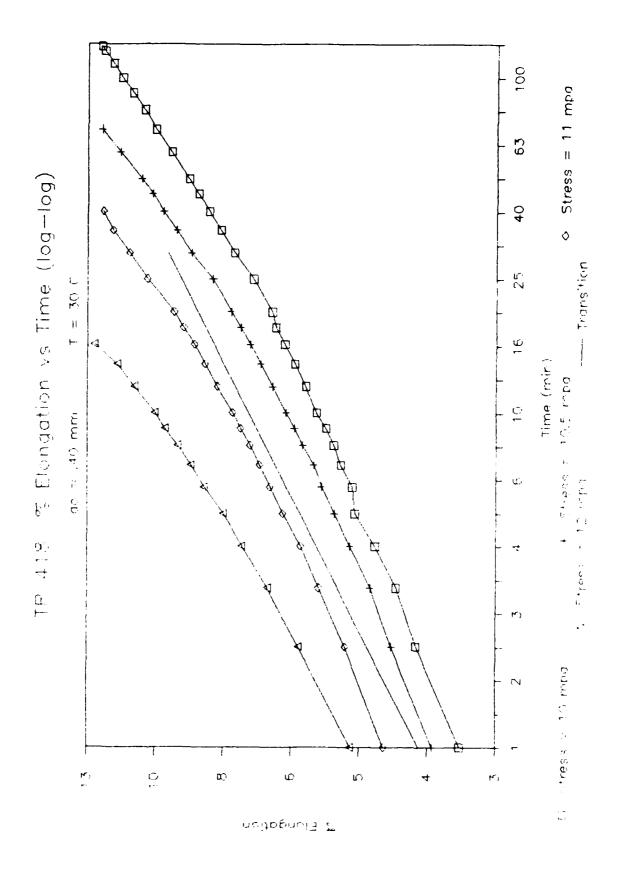
Analyzing the percent elongation curves plotted on log-log scales for TR 418 (Figures 42, 43, 44, and 45) a straight line can again be used to approximate the portion of the curve between initial loading and ultimate failure giving a relationship for creep. Equation (2)

can also be used to represent this relation. A and m are again constants for a given set of experimental conditions and are presented as Tables 8, 9, 10, and 11 and graphically as Figures 71, 72, 73, and 74. Again A is seen to depend considerably on stress with a slight stress dependence being shown for m.

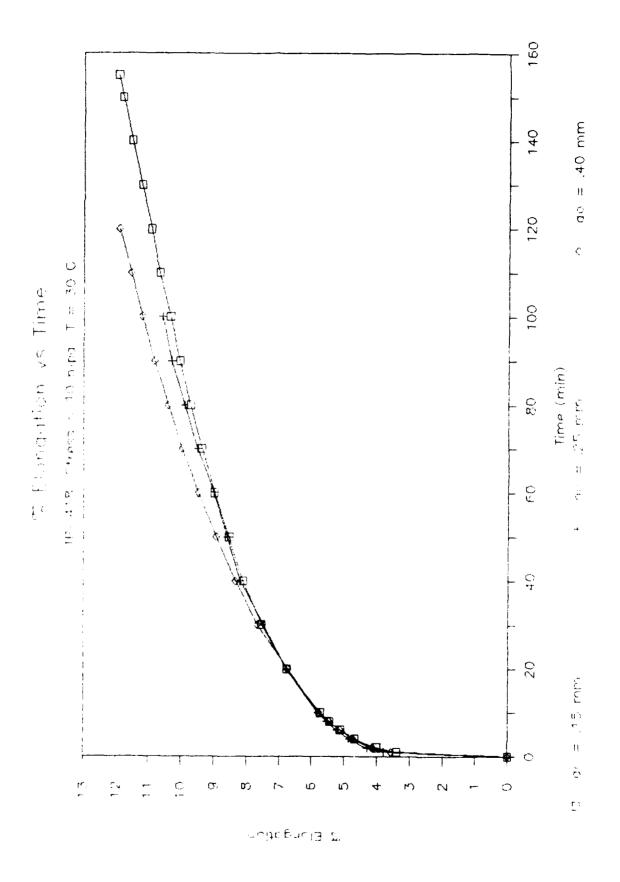
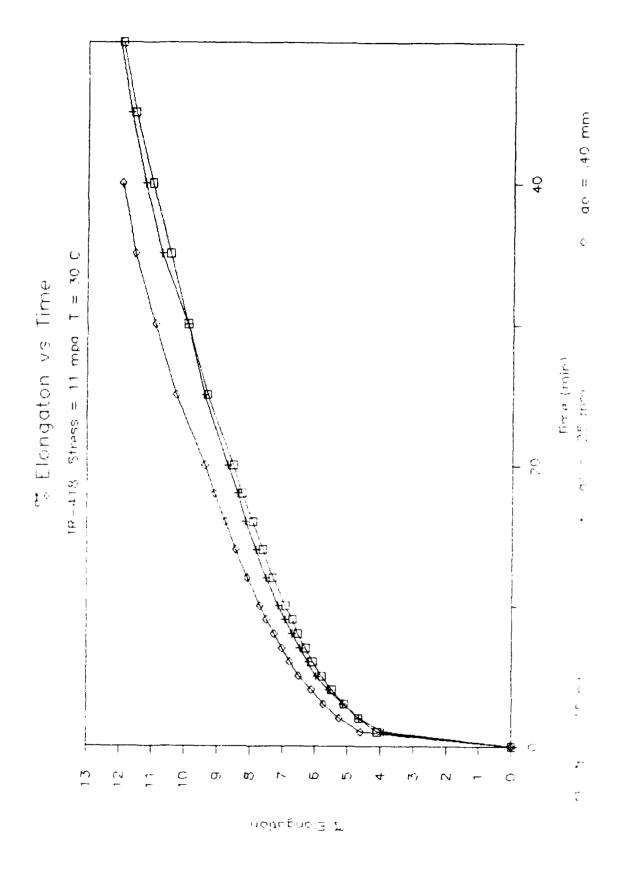
Figures 49, 50, and 51 compare the TR 418 percent elongation vs time curves for the same conditions and Figures 52, 53, and 54 present these on a log-log scale. At stresses of 10 and 11 mpa there is little dependence on notch depth. At 13 mpa there appears to be some notch dependence which is seen only upon initial loading. This suggests that the elongation of the specimen is only being affected by creep and not the brittle fracture process.

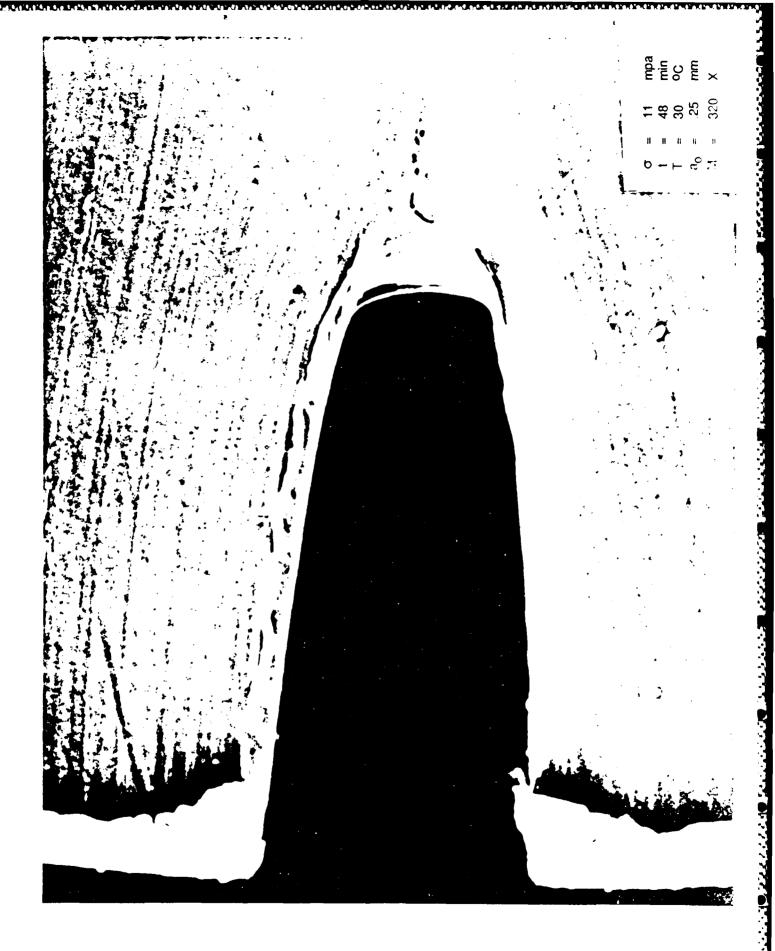
The electron microscopic studies for TR 418 at a notch depth of .25 mm are presented figures 55 through 58. All of the crack tips are blunted even at the low stress levels but there is a damage zone in front of the crack tip that seems to behave in a fashion similar to the crack tip in Marlex 6006. Flgures 59 through 62 present the same views at a higher magnification. Some porosity is exhibited at

all stress levels but it is greater at the lower stresses. The damage zone gets longer and sharper as the stress level decreases and there actually seems to be a blunting in the damage zone at 11 mpa, which is above the transition stress. This indicates that even though the brittle fracture process did not appear as that seen in Marlex 6006, there is some damage process advancing through the material at the lower stress levels.
